NATIONAL DAM INSPECTION PROGRAM. MEMORIAL LAKE DAM (NDI NUMBER --ETC(U)

6 National Dam Inspection Program.
Memorial Lake DAM (NDI Number PA-00603,
DER Number 38-80), Susquehanna River
Basin, Lebanon County, Pennsylvania.
Phase I Inspection Report.

PHASE I REPORT
NATIONAL DAM INSPECTION PROGRAM

Name of Dam: MEMORIAL LAKE DAM, NDI NO. PA-00603
State & State No. PENNSYLVANIA, 38-80
County: LEBANON
Stream: INDIANTOWN RUN
Date of Inspection: November 11, 1978

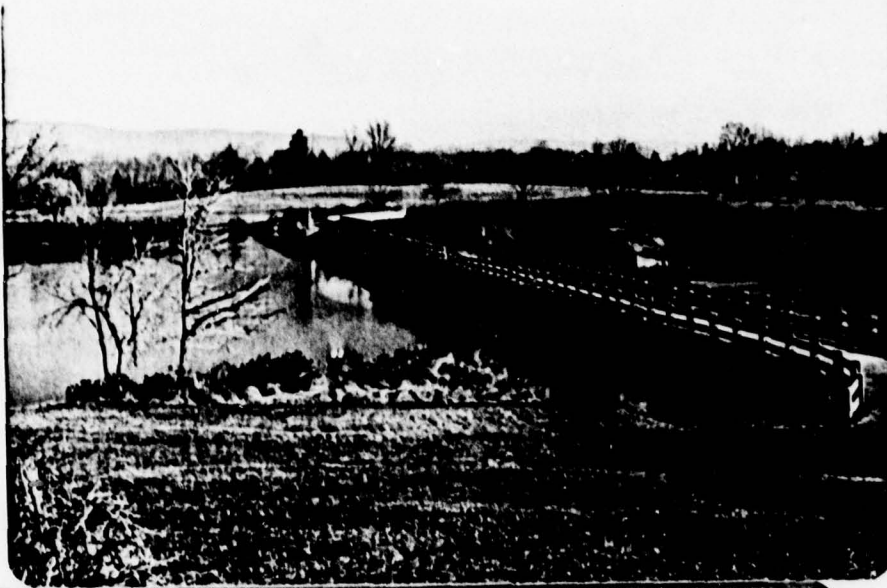
| | OBSERVATIONS AND REMARKS |
|--|--|
| K. COVER (GROWTH) | Upstream - loose small stones - some weeds and brush. Breast - blacktop and concrete railing. Downstream - loose small stone- some weeds & brush. |

Right Abutment
& Upstream Slope

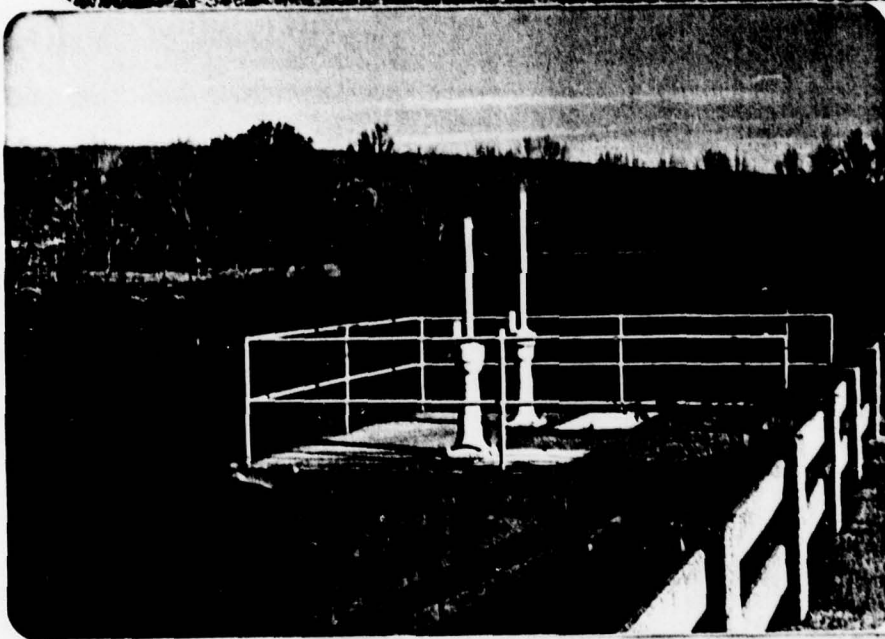
Since 1963, the stem guide brackets on the 48-inch sluice gate have been loose, causing the stem to bend. The gate is of the unseating pressure type and is leaking slightly.

The available operating records are limited to some inspection reports. The main problem is the non-operable condition of the drawdown sluice gate, due to the loosening of two stem guides. The gate is of the unseating pressure type, which often leaks.

| | OBSERVATIONS AND REMARKS |
|---|--|
| D. GATES | 48-inch unseated gate, leaking. Gate stem bent at several places. Stem guide torn loose from concrete. Unoperable. Operator stand operates a weir in a separate chamber. |

Control Tower

1. The stem on the drawdown sluice gate should be repaired immediately to facilitate the use of this gate during emergencies.

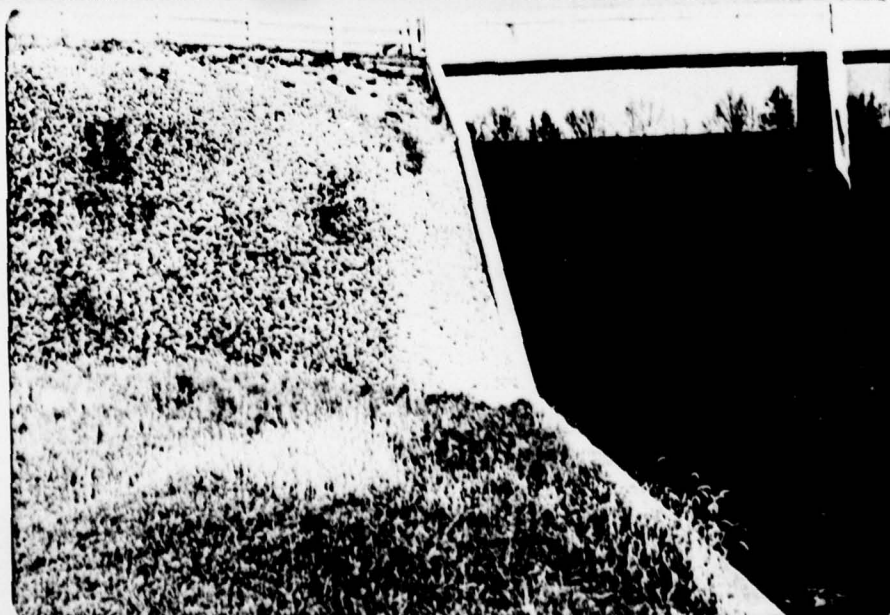
The upstream slope of the embankment has a loose stone facing with some weeds and brush growth. The top of the dam has a blacktop paving and a pedestrian railing. The horizontal and vertical alignment of the crest were good (see Appendix A, sketch). The downstream slope is also covered with loose stone, some weeds and small brush. No sloughing, erosion or unusual toe movements were detected. A wet area was observed adjacent to the right spillway wall just beyond the toe of the dam.

Wet Area at Toe
Near Spillway

1. The stem on the drawdown sluice gate should be repaired immediately and this gate should be operated on a semi-annual basis.
2. The end of the spillway slab should be protected against undermining.
3. The wet area adjacent to the spillway should be properly drained and closely observed.
4. The brush on the embankment should be removed and a maintenance schedule for control of weeds on the embankment slope should be established.

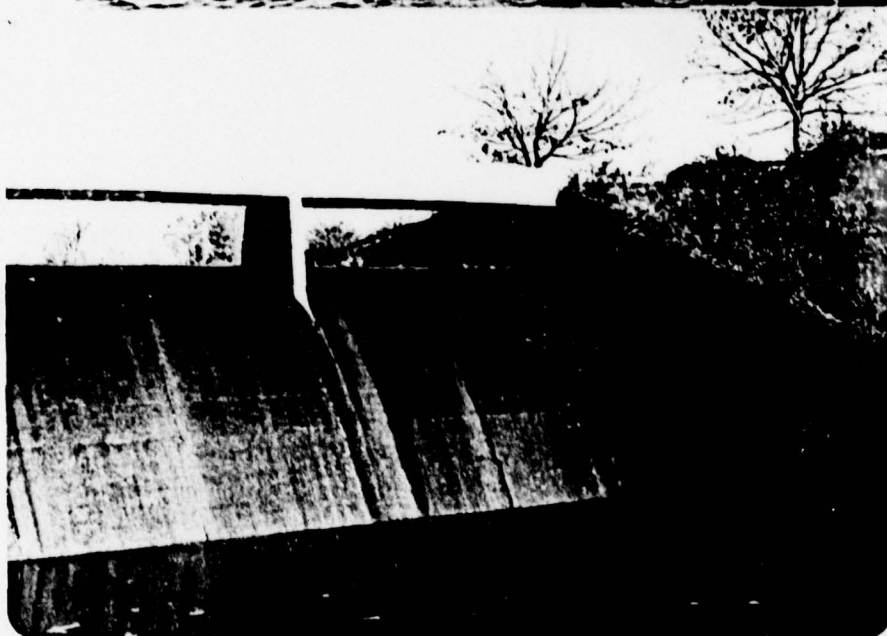
Left Spillway
Wall

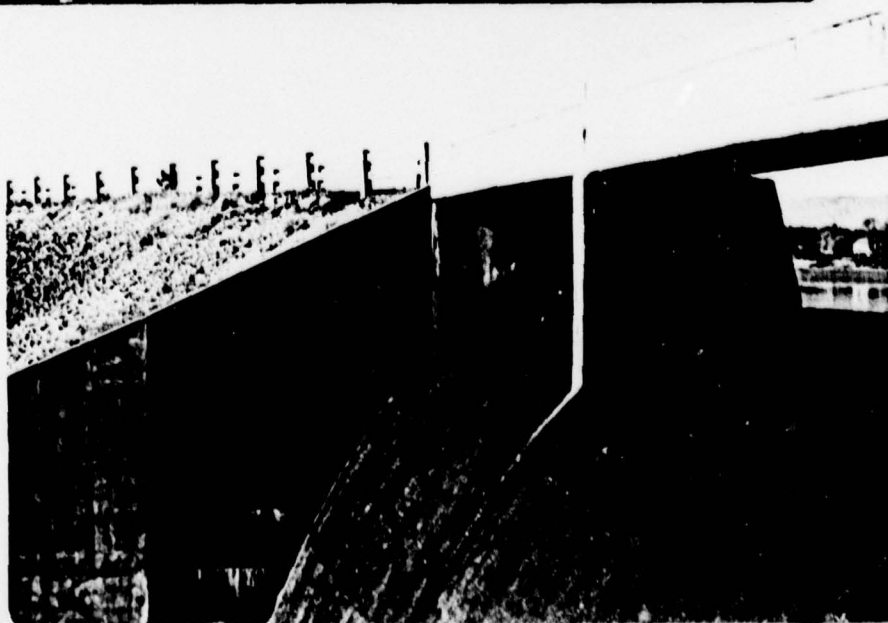
No formal records of operation are maintained. Inspection reports indicate that a few inches of settlement occurred around the right seepage fin of the spillway in 1950. This probably was the result of poor compaction around the fin. Seepage at the toe near the right spillway wall was noticed and is still present. Other wet areas were present along the toe, mostly caused by poor drainage in this flat area.

Right Spillway
Wall
